Incident Alert

Mooring Shackle Failure

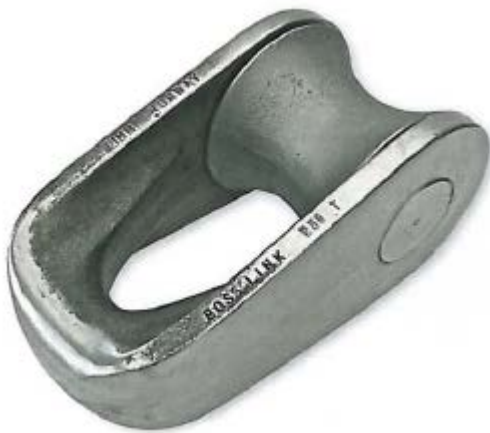
Timm Boss Link 120T

490171: When carrying out mooring inspections after a LPW (Long Period Wave) event two Norwegian shackles were found with severe cracking in the staple end.

- Boss Link failure has resulted from the presence of significant shrinkage cracks at the bow end which formed during solidification of the casting. Shrinkage cracking was noted to be predominantly sub-surface.

- Exposure to cyclic stress has resulted in fatigue crack propagation from these defects, giving rise to Boss Link cracking now apparent.
 - Chemical analysis showed that the link material was not consistent with wrought alloy grade 329 stainless steel.

- The Shackles were removed from service and a full inspection of all shackles conducted. A failed shackle was sent for metallurgy tests and the results found to be:

- Inspection schedule adjusted to ensure full visual inspection carried out after every shipping cycle
- All Shackles have been crack tested by in house engineering team and 8 cracked shackles have been removed from service (58 in use total)

- Currently researching alternatives to replace entire stock

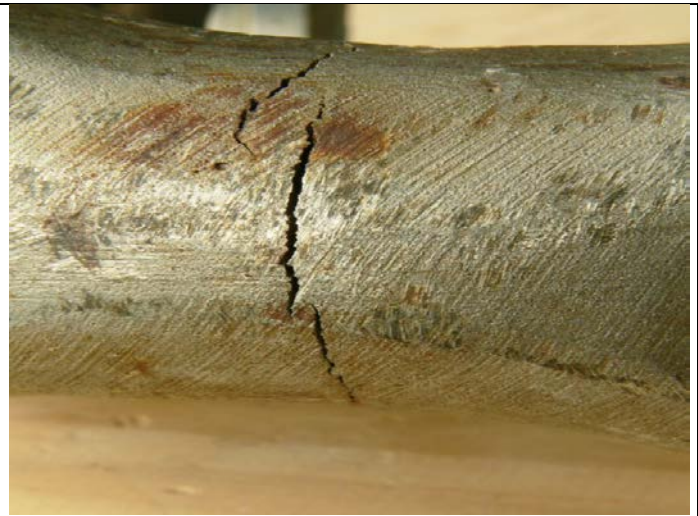
Image showing the cracks at the Bow end of the shackle
